**Flood Control Project Maintenance
Levee Inspections
LMA District Cover Sheet
Spring 2010 Levee Inspection Results**

Reclamation District No. 2058 Pescadero

Waterway			Bank	Unit Miles
Unit No. 01 Paradise Cut			Left	6.71

Levee Inspection Report By Mile - Spring 2010

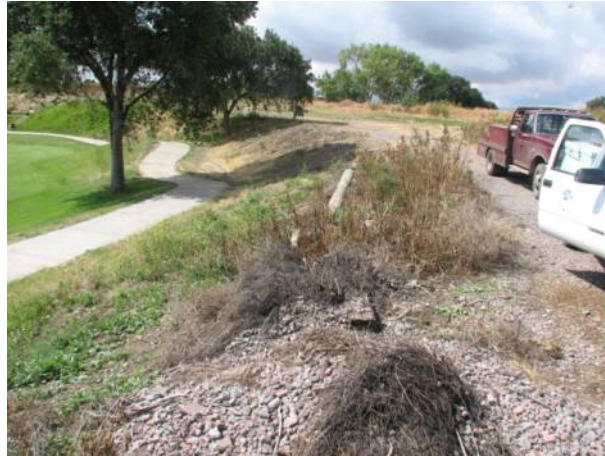
Levee Mile Report Line	1
Start Levee Mile	0.03
End Levee Mile	0.03
Location	Land Side
Category	Earthen Levee
Item	Encroachments

LMR No	Levee Mile		Category	Item	Location	Rating	Action/Comment	GPS Latitude/Longitude		Issue No. Photo
	Start	End						Start	End	
1	0.03	0.03	Earthen Levee	Encroachments	LS	M	Material Inspector Comments: Poles and concrete on slope.	37.801967 ° -121.420512 °	37.801967 ° -121.420512 °	3 Y
2	0.05	0.05	Earthen Levee	Encroachments	WS	M	Debris Inspector Comments: Rusted metal pipe and concrete is present within 20-ft of crown.	37.802209 ° -121.420356 °	37.802209 ° -121.420356 °	946
3	0.12	0.12	Earthen Levee	Animal Control	WS	M	No rodents visible, but rodent burrows visible; need to backfill and compact or grout borrows. Inspector Comments: Burrow holes on water side of crown. Levee crown is abnormally wide at this point.	37.803012 ° -121.419732 °	37.803012 ° -121.419732 °	947
4	0.14	0.14	Earthen Levee	Animal Control	LS	M	Exterminate rodents and backfill and compact or grout burrows.	37.803316 ° -121.419494 °	37.803316 ° -121.419494 °	7 Y

Wood poles, railroad ties and other debris on landside slope should be removed though they appear to prevent access to cart path.

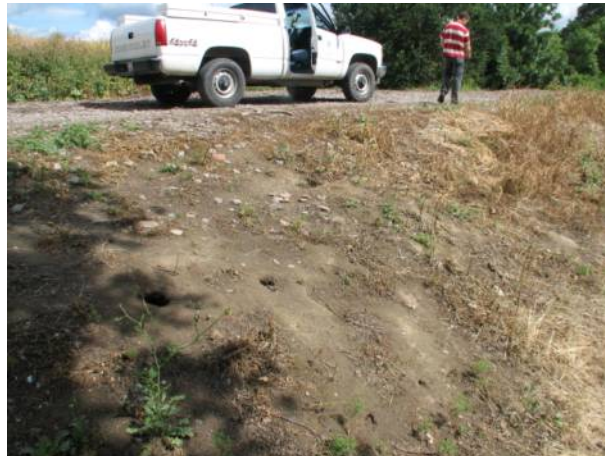
Levee Mile Report Line	4
Start Levee Mile	0.14
End Levee Mile	0.14
Location	Land Side
Category	Earthen Levee
Item	Animal Control

Active animal burrows on landside slope.

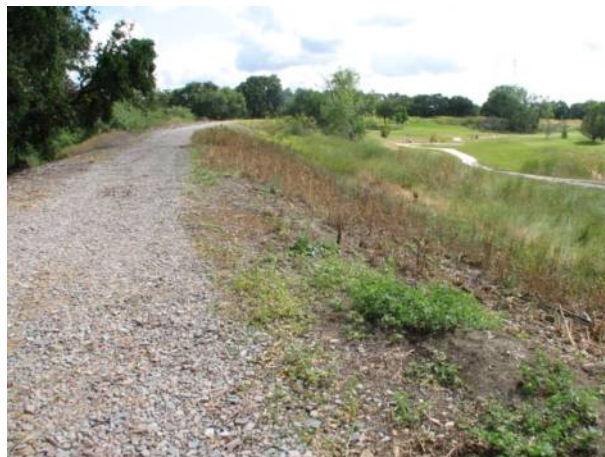
Levee Mile Report Line	6
Start Levee Mile	0.18
End Levee Mile	0.29
Location	Land Side
Category	Earthen Levee
Item	Vegetation

5	0.15	0.18	Earthen Levee	Encroachments	WS	C	Prunings Inspector Comments: Prunings piled on water side hinge point are obstructive.	37.803416 ° -121.419411 °	37.803876 ° -121.419042 °	948
6	0.18	0.29	Earthen Levee	Vegetation	LS	M	Control annual grass and weeds on the levee slopes and easements. Inspector Comments: Removal of this type of vegetation is currently prohibited by FWS due to concerns with RBR.	37.803786 ° -121.419120 °	37.804719 ° -121.417548 °	8 Y
7	0.19	0.21	Earthen Levee	Trim / Thin Trees	WS	C	Trim trees to at least five feet above ground level.	37.803853 ° -121.419083 °	37.804025 ° -121.418712 °	4
8	0.19	0.19	Earthen Levee	Animal Control	WS	M	Exterminate rodents and backfill and compact or grout burrows.	37.803951 ° -121.418961 °	37.803951 ° -121.418961 °	10
9	0.21	0.21	Earthen Levee	Encroachments	WS	M	Prunings	37.804084 ° -121.418827 °	37.804084 ° -121.418827 °	12
10	0.27	0.29	Earthen Levee	Trim / Thin Trees	WS	C	Trim trees to at least five feet above ground level.	37.804553 ° -121.417967 °	37.804657 ° -121.417567 °	936

Vegetation on landside slope and toe. Dense brush

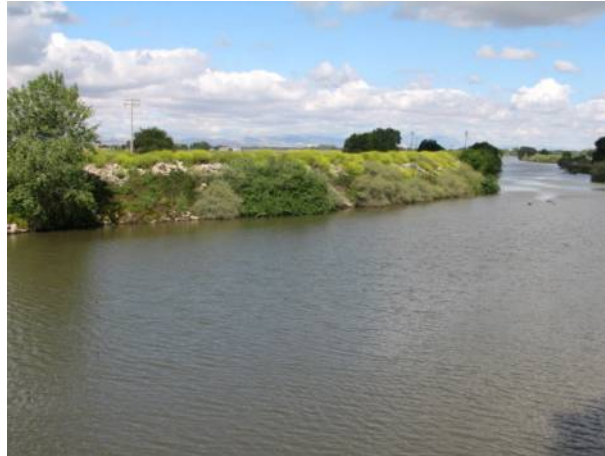
Levee Mile Report Line	13
Start Levee Mile	0.34
End Levee Mile	3.11
Location	Water Side
Category	Earthen Levee
Item	Vegetation
Obstructive Mustard Weed on levee crown and top 20' of waterside slope. Photo taken from Paradise Ave bridge.	
jpaasch_s_20100528_455.jpg

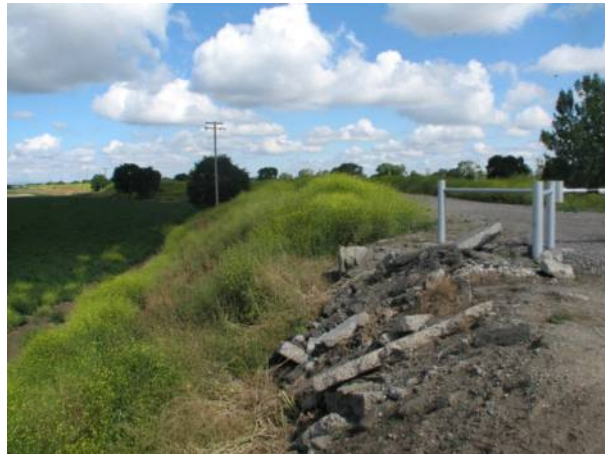
Waterway						Bank	Unit Miles	Inspection Start/End	Inspector	
Unit No. 01 Paradise Cut						Left	6.71	05/26/2010 05/26/2010	John Paasch	
LMR No	Levee Mile		Category	Item	Location	Rating	Action/Comment	GPS Latitude/Longitude		Issue No. Photo
	Start	End						Start	End	
14	0.35	3.11	Earthen Levee	Vegetation	LS	M	Control annual grass and weeds on the levee slopes and easements. Inspector Comments: If condition persists rating in Fall will be U. District has begun a grazing program to manage the vegetation.	37.804207 ° -121.416628 °	37.799686 ° -121.369777 °	20 Y
15	0.41	0.43	Earthen Levee	Vegetation	WS	M	Remove the wild growth other than native grasses from the levee slopes. Inspector Comments: Brush within 20-ft of levee crown impedes access and visibility. Removal of this type of vegetation is currently prohibited by FWS due to concerns with RBR.	37.803831 ° -121.415718 °	37.803668 ° -121.415530 °	949

Levee Mile Report Line	14
Start Levee Mile	0.35
End Levee Mile	3.11
Location	Land Side
Category	Earthen Levee
Item	Vegetation
Mustard weed obstructs access and visibility to landside slope and toe.	
jpaasch_s_20100528_456.jpg

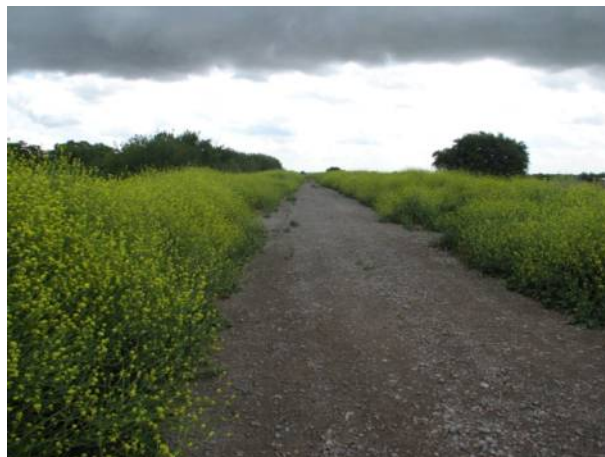
Levee Mile Report Line	22
Start Levee Mile	0.79
End Levee Mile	3.11
Location	Crown
Category	Earthen Levee
Item	Vegetation
Mustard weed on levee crown obstructs visibility and access.	
jpaasch_s_20100528_462.jpg

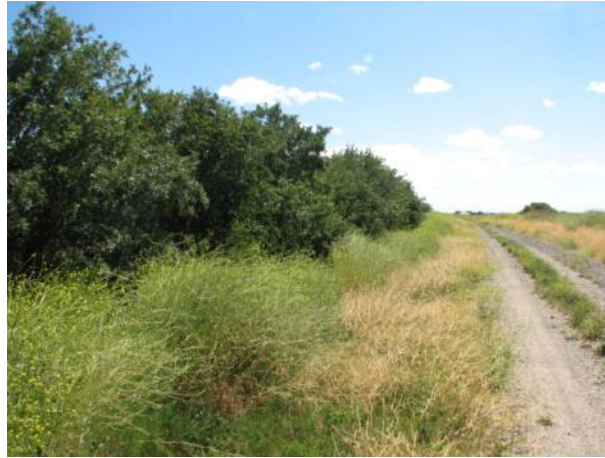
Levee Mile Report Line	23
Start Levee Mile	0.82
End Levee Mile	0.93
Location	Water Side
Category	Earthen Levee
Item	Trim / Thin Trees

Dense trees on waterside slope obstruct access and visibility.

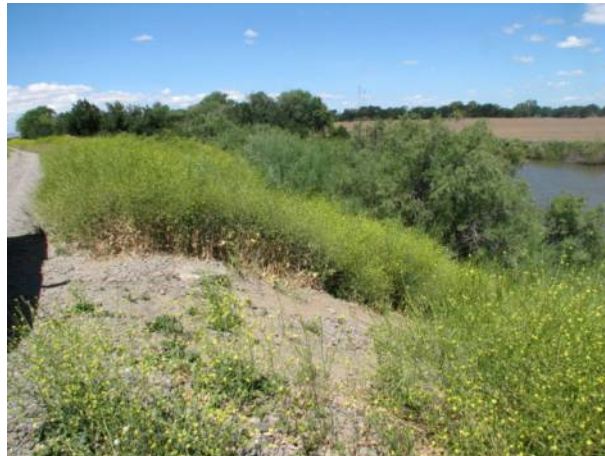
Levee Mile Report Line	27
Start Levee Mile	1.22
End Levee Mile	1.22
Location	Water Side
Category	Earthen Levee
Item	Vegetation

Dense brush on top 20' of waterside slope obstructs access and visibility.

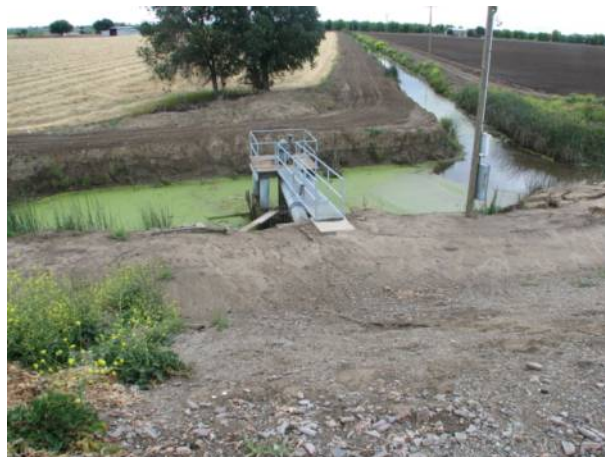
Levee Mile Report Line	28
Start Levee Mile	1.24
End Levee Mile	1.24
Location	Crown
Category	Earthen Levee
Item	Encroachments

Drainage discharge to Paradise Cut.

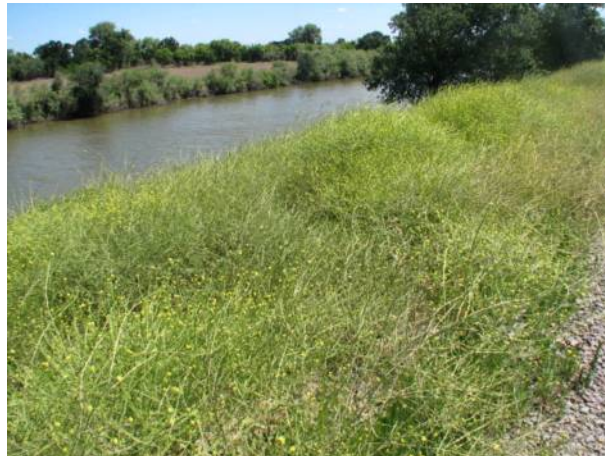
Levee Mile Report Line	31
Start Levee Mile	1.34
End Levee Mile	1.34
Location	Water Side
Category	Earthen Levee
Item	Vegetation

Tall brush on top 20' of waterside slope obstructs access and visibility.

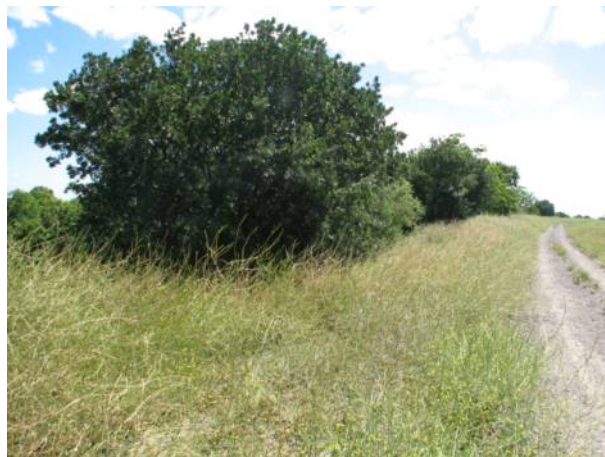
Levee Mile Report Line	37
Start Levee Mile	1.89
End Levee Mile	1.92
Location	Water Side
Category	Earthen Levee
Item	Trim / Thin Trees

Dense trees on top 20' of waterside slope obstructs access and visibility.

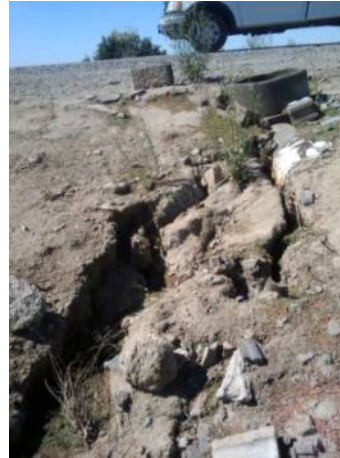
Levee Mile Report Line	39
Start Levee Mile	2.15
End Levee Mile	2.15
Location	Water Side
Category	Supplemental
Item	DWR Erosion Survey

2009: A possible leak or spill from a siphon breaker is eroding the slope and developing into a headward erosion; a portion of the buried pipe is exposed; the lower slope seems to be lined with chunks of concrete debris or other rock material [2009 SiteID:RD2058U1RM1.78]

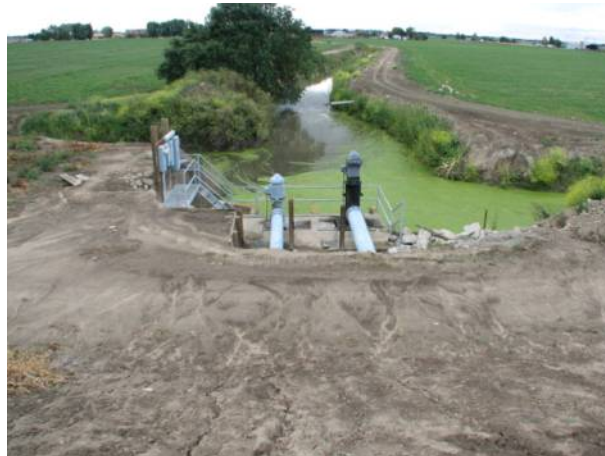
Levee Mile Report Line	40
Start Levee Mile	2.15
End Levee Mile	2.15
Location	Crown
Category	Earthen Levee
Item	Encroachments

Drainage discharge to Paradise Cut.

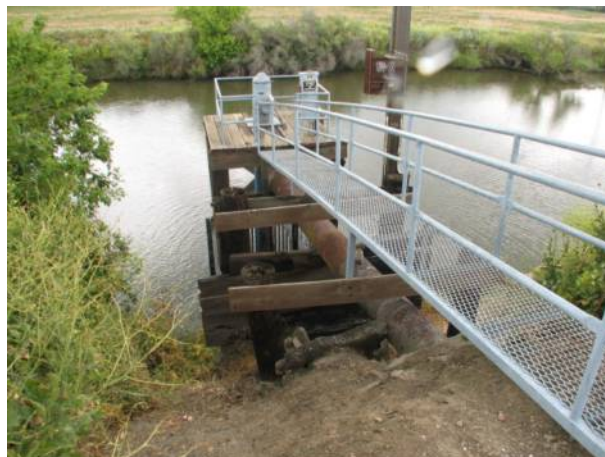
Levee Mile Report Line	45
Start Levee Mile	2.89
End Levee Mile	2.89
Location	Water Side
Category	Earthen Levee
Item	Encroachments

Irrigation intake from Paradise Cut.

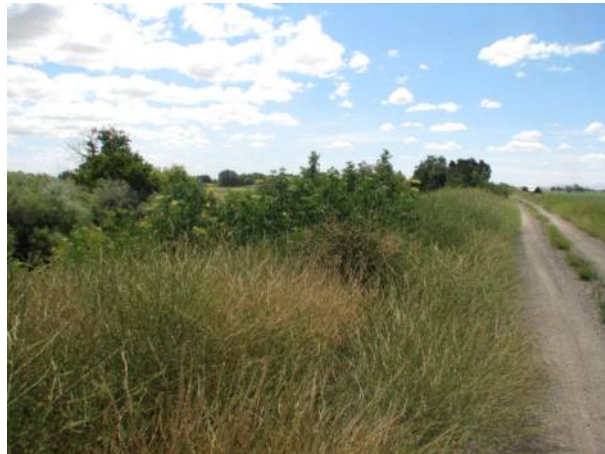
Levee Mile Report Line	54
Start Levee Mile	3.77
End Levee Mile	3.77
Location	Water Side
Category	Earthen Levee
Item	Vegetation
Tall brush on top 20' of waterside slope obstructs access and visibility.	
jhirabay_s_20100614_472.jpg

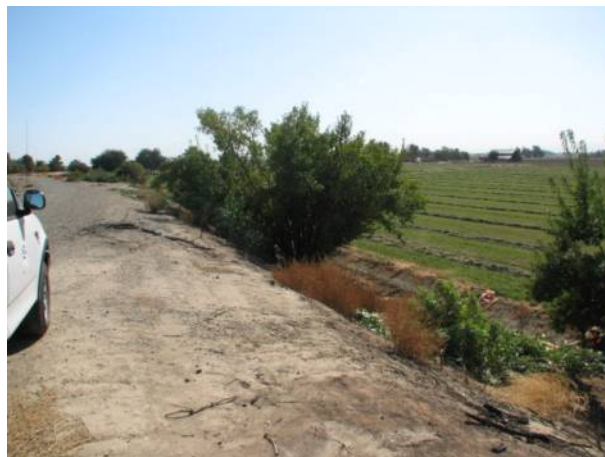
55	3.96	3.96	Earthen Levee	Trim / Thin Trees	LS	M	Trim trees to at least five feet above ground level. Inspector Comments: Condition of trees has not changed.	37.789398 ° -121.361713 °	37.789398 ° -121.361713 °	975 Y
56	3.97	4.03	Earthen Levee	Encroachments	LS	PO	Fences Inspector Comments: Mangled barbed wire fence on levee slope	37.789369 ° -121.361644 °	37.789005 ° -121.360694 °	976
57	4.01	4.01	Earthen Levee	Trim / Thin Trees	LS	M	Trim trees over roadway to at least 12 feet above ground level.	37.789105 ° -121.360988 °	37.789105 ° -121.360988 °	28
58	4.09	4.09	Earthen Levee	Encroachments	CR	M	Tree or limb Inspector Comments: Fallen tree on levee slope and crown limits access.	37.788813 ° -121.359523 °	37.788813 ° -121.359523 °	29
59	4.10	4.10	Earthen Levee	Trim / Thin Trees	LS	M	Trim trees to at least five feet above ground level.	37.788730 ° -121.359537 °	37.788730 ° -121.359537 °	9
60	4.10	4.10	Earthen Levee	Encroachments	LS	M	Debris Inspector Comments: Straw, plastic and cuttings on levee slope and crown.	37.788803 ° -121.359316 °	37.788803 ° -121.359316 °	977

Levee Mile Report Line	55
Start Levee Mile	3.96
End Levee Mile	3.96
Location	Land Side
Category	Earthen Levee
Item	Trim / Thin Trees
Fall 2009 photo of trees needing trimming to allow access and visibility.	
jpaasch_s_20100330_154.jpg

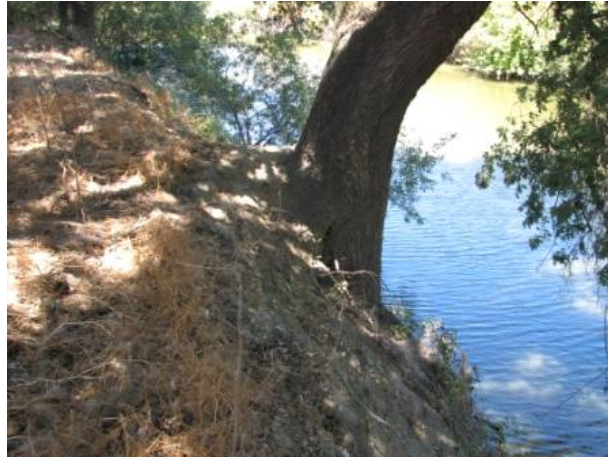
Levee Mile Report Line	61
Start Levee Mile	4.49
End Levee Mile	4.53
Location	Water Side
Category	Supplemental
Item	DWR Erosion Survey

61	4.49	4.53	Supplemental	DWR Erosion Survey	WS	M	Inspector Comments: 2009: No major change observed; site is a 200 ft long near-vertical berm erosion; recommend annual assessment and monitoring of erosion site, per CLRO CES Evaluation 2008 Report; site # is same as RM4.0,LM4.51; previously rated "U" [2009 SiteID:RD2058U1RM3.97]	37.789810 ° -121.352490 °	37.789810 ° -121.352490 °	2 Y
62	4.58	4.58	Earthen Levee	Animal Control	WS	C	Exterminate rodents and backfill and compact or grout burrows.	37.789263 ° -121.351352 °	37.789263 ° -121.351352 °	978
63	4.81	4.81	Earthen Levee	Trim / Thin Trees	WS	M	Trim trees to at least five feet above ground level.	37.786005 ° -121.350508 °	37.786005 ° -121.350508 °	941
64	4.83	4.83	Earthen Levee	Animal Control	LS	C	Exterminate rodents and backfill and compact or grout burrows.	37.785810 ° -121.350279 °	37.785810 ° -121.350279 °	979

2009: No major change observed; site is a 200 ft long near-vertical berm erosion; recommend annual assessment and monitoring of erosion site, per CLRO CES Evaluation 2008 Report; site # is same as RM4.0,LM4.51; previously rated "U" [2009 SiteID:RD2058U1RM3.97]

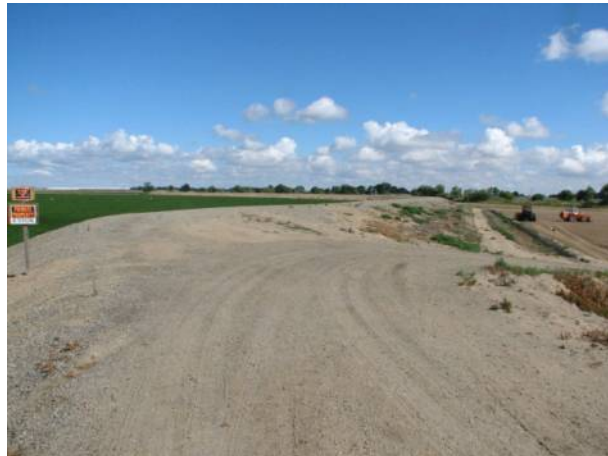
Levee Mile Report Line	70
Start Levee Mile	6.01
End Levee Mile	6.57
Location	Land Side
Category	Earthen Levee
Item	Vegetation

70	6.01	6.57	Earthen Levee	Vegetation	LS	A	Control annual grass and weeds on the levee slopes and easements. Inspector Comments: Levee free of obstructive vegetation.	37.775558 ° -121.335838 °	37.770145 ° -121.329648 °	32 Y	
71	6.01	6.01	Earthen Levee	Encroachments	WS	M	Garbage Inspector Comments: No change since last inspection.	37.775558 ° -121.335830 °	37.775558 ° -121.335830 °	13	
72	6.42	6.42	Earthen Levee	Animal Control	LS	M	No rodents visible, but rodent burrows visible; need to backfill and compact or grout borrows. Inspector Comments: Numerous burrows remain on levee.	37.772047 ° -121.330188 °	37.772047 ° -121.330188 °	985

Levee free of obstructive vegetation.
